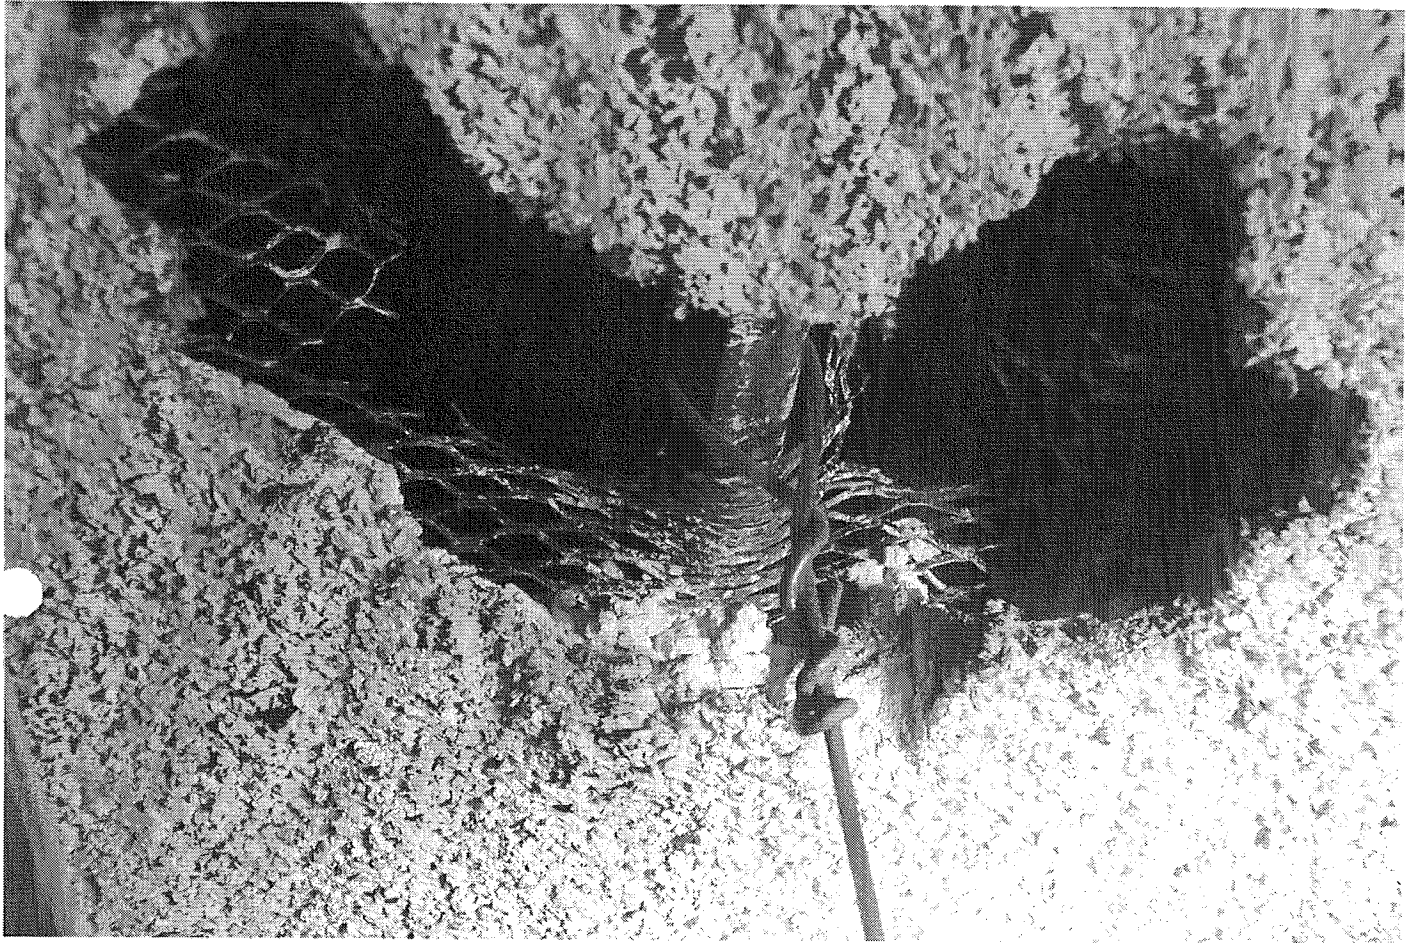
7. 1st floor, City Counsel Chambers - Close-up of damaged acoustical plaster (note: fibrous nature of material)

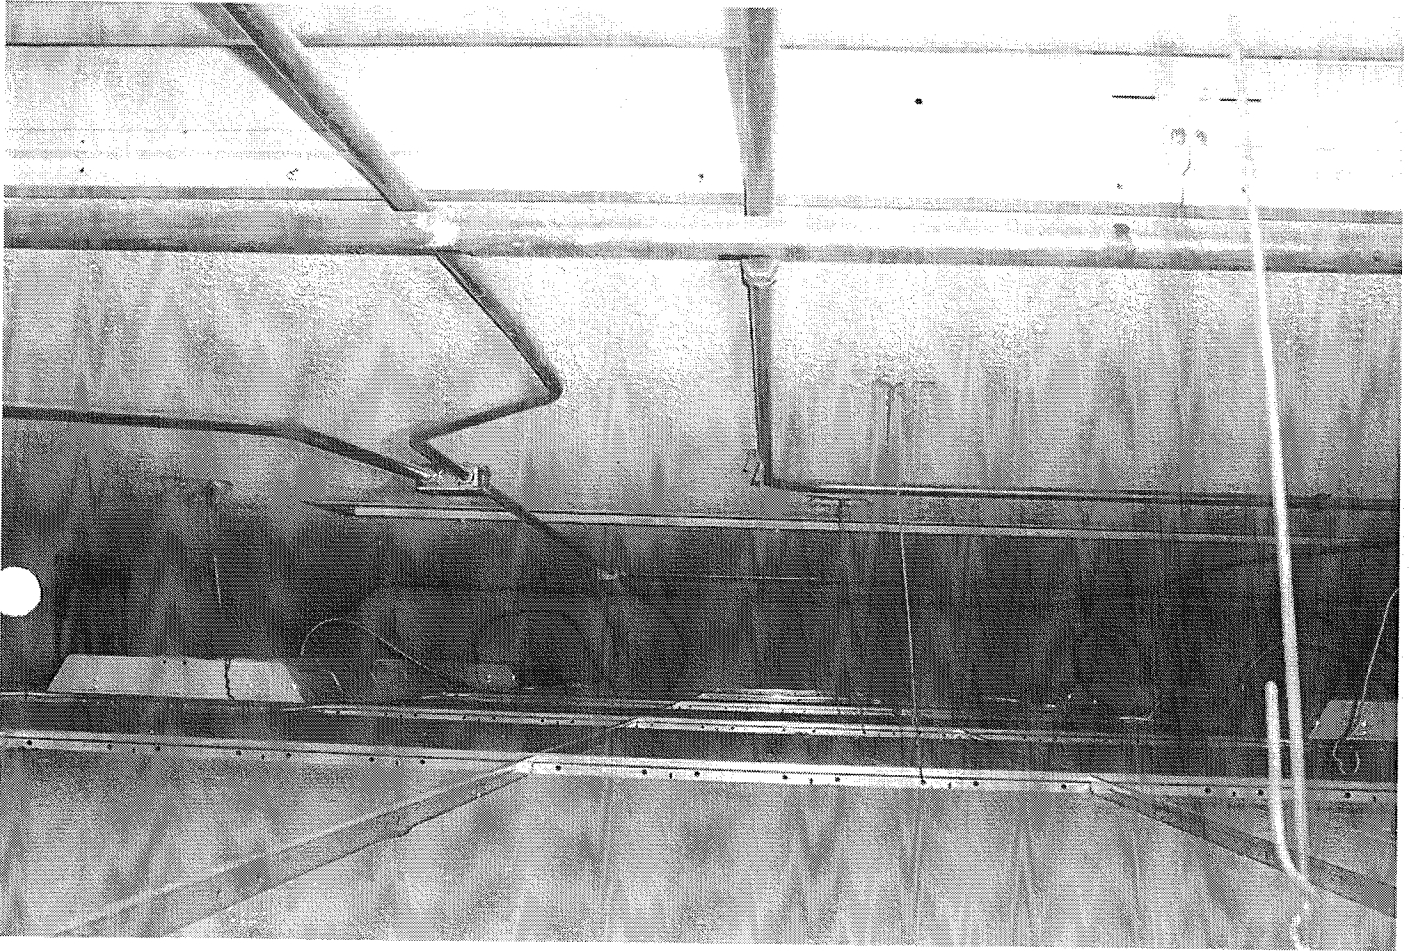
8. 1st floor, City Counsel Chambers - General view of hanger wires and electrical conduit attached to acoustical sprayed ceiling

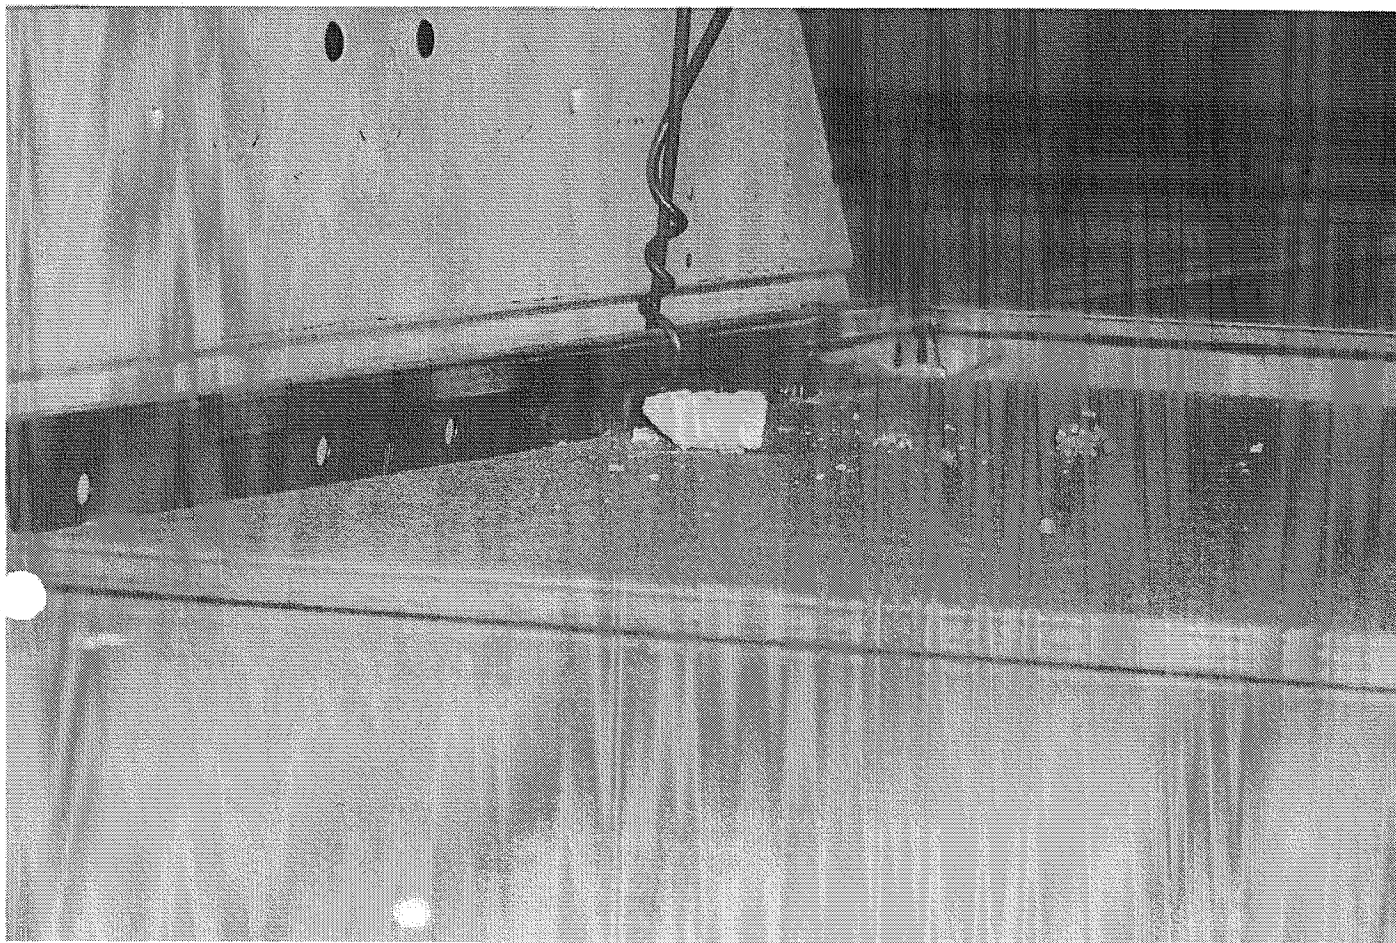
9. 1st floor, City Counsel Chambers - Close-up of dislodged acoustical plaster debris on top of ceiling tile (location of dust sample #3)

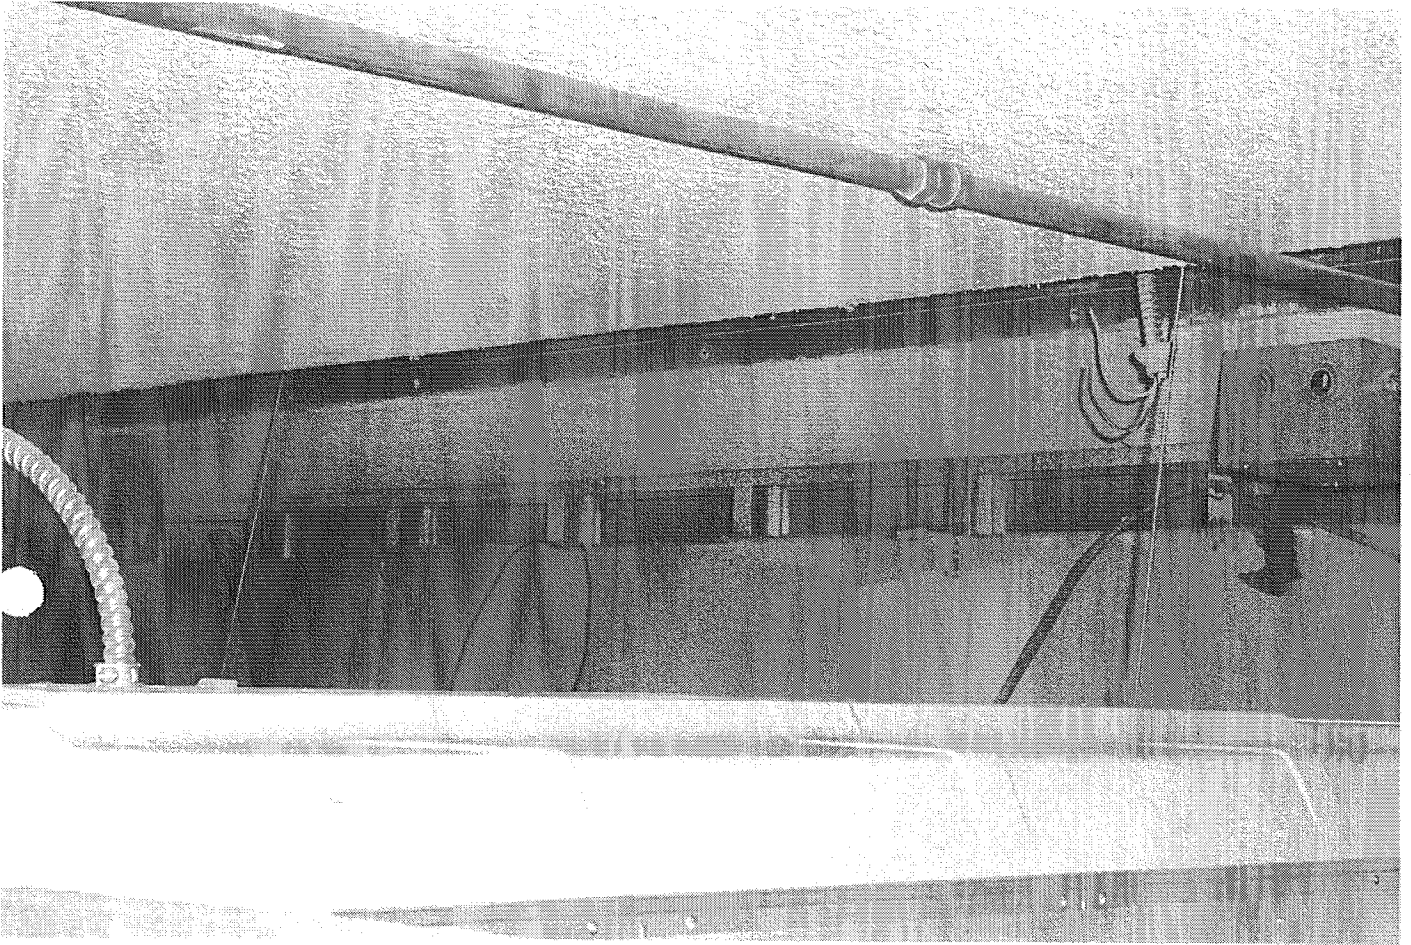
10. 1st floor, City Counsel Chambers - View of demising wall impacting acoustical plaster above suspended ceiling

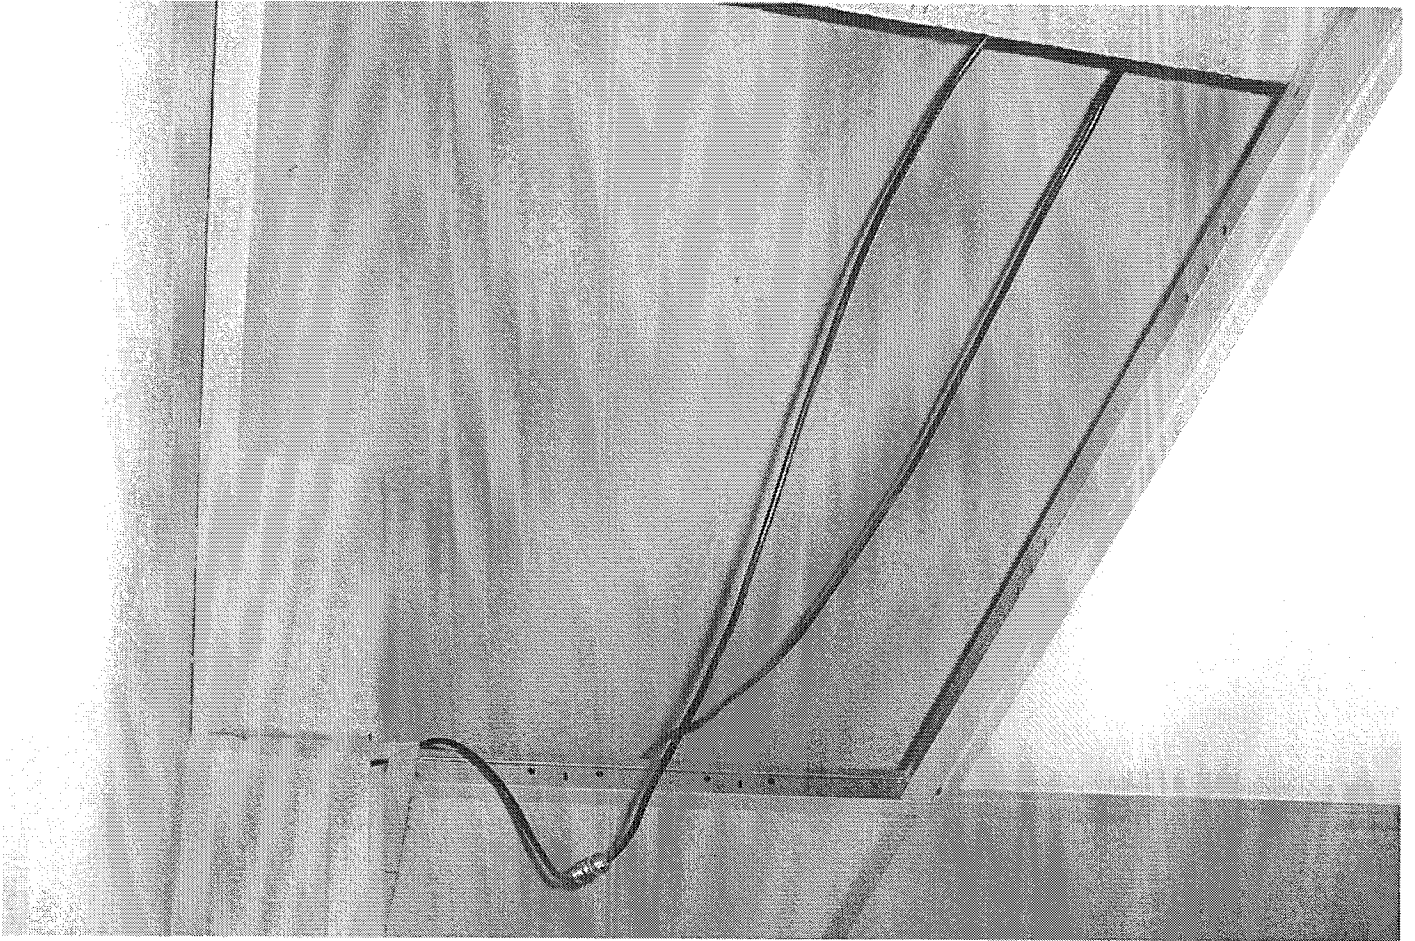
*1. 2nd floor, copy area outside large Conference Rm - View of acoustical plaster above suspended ceiling (general location of dust samples #4 and #5)
